**AIR ACCIDENT INVESTIGATION  
& AVIATION SAFETY BOARD  
(AAIASB)**

**AIRCRAFT ACCIDENT REPORT**

**HELIOS AIRWAYS FLIGHT HCY522  
BOEING 737-31S  
AT GRAMMATIKO, HELLAS  
ON 14 AUGUST 2005**

Accident of the a/c 5B-DBY of Helios Airways,  
Flight HCY522 on August 14, 2005,  
in the area of Grammatiko, Attikis,  
33 km Northwest Of Athens International Airport

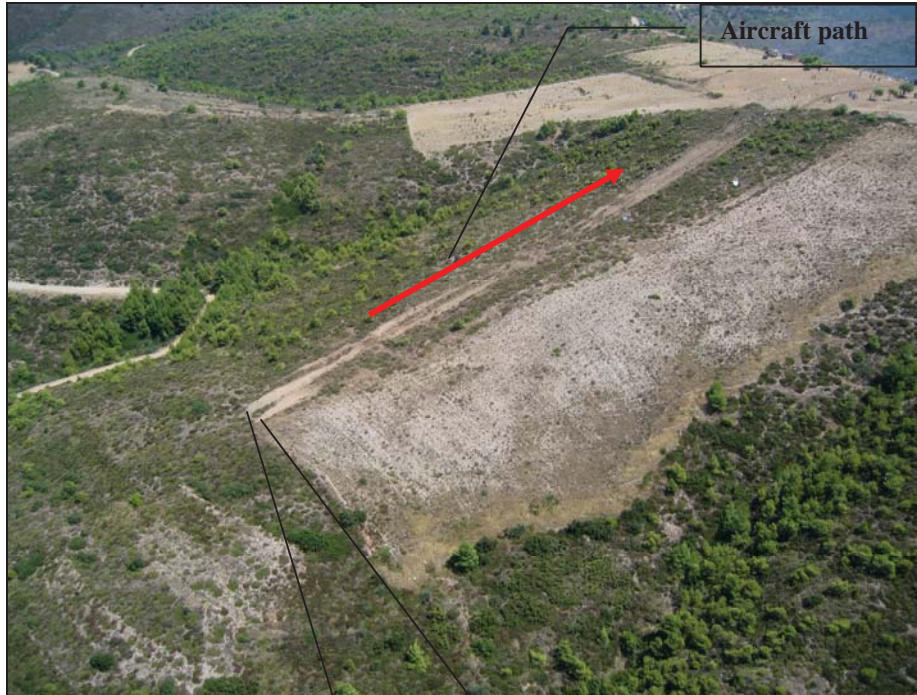
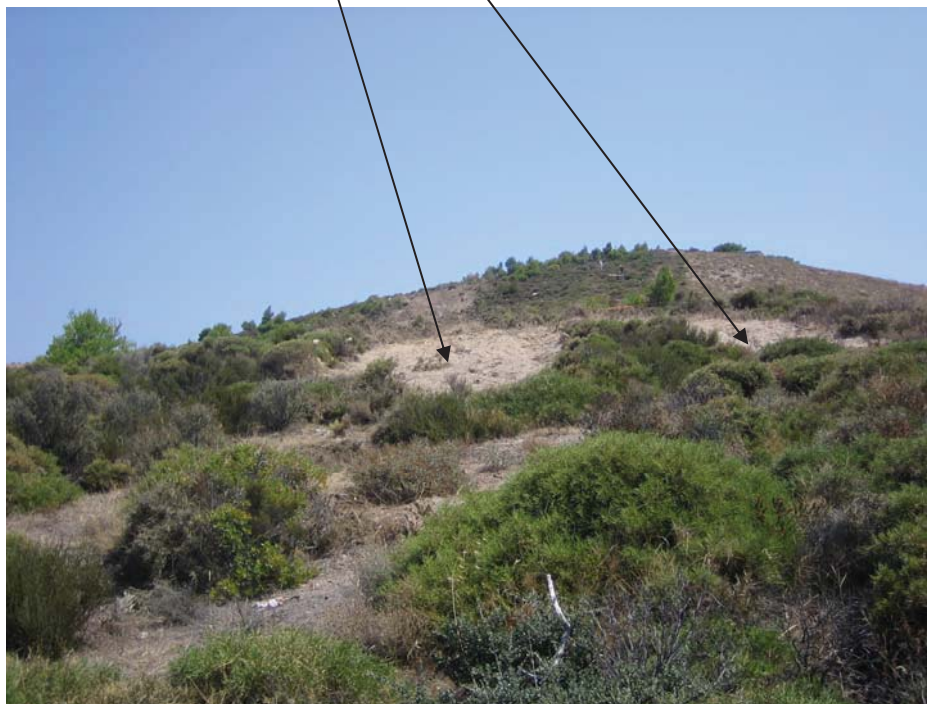
Two adjacent dirt paths (gouges) were found at the initial impact area, which matched the spacing of the fuselage to the right engine. The dirt paths passed through low vegetation on the first uphill slope (See photos on the next page). The wider path was found to be consistent with the 3.7 m width of the fuselage and the adjacent path to the right was consistent with the 2.4 m width of the engine. A third dirt path was found to the left, 10 m down-track from the initial contact of the fuselage and right engine. The location of this dirt path was consistent with the spacing of the left engine from the initial impact of the fuselage and right engine. A 35 cm wide slice through the vegetation began 9 m to the right of the fuselage centerline and 5 m down-track from the initial contact of the fuselage and right engine.

**Photos – Initial impact area and first two contact paths on first uphill slope. The path with the width of the fuselage begins in the center of the photo and the path with the spacing and width of the right engine begins near the right side. The slope of the hill is visible as darkening of the path. For scale, the two people immediately beneath the peak of the hill are barely visible.**

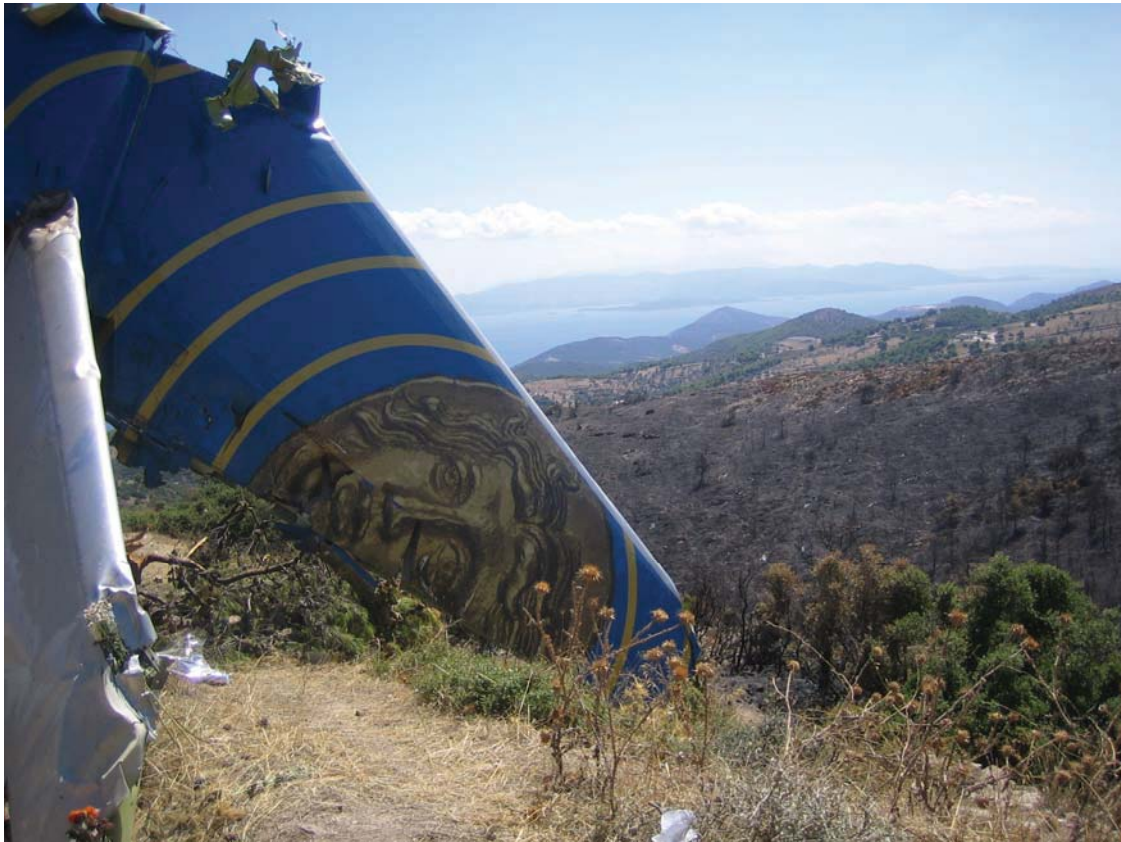
**Photo – The tail assembly near the crest of the first hill, with the distant crest of the second hill in the background.**

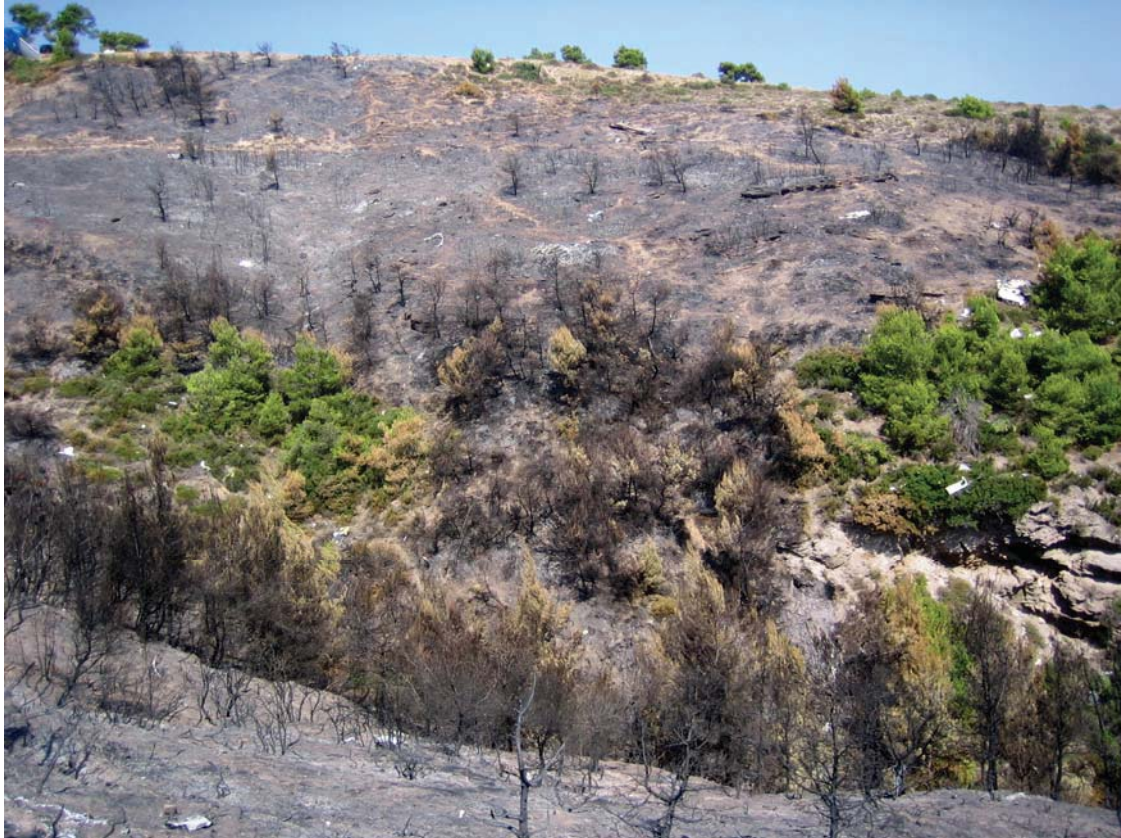
**Photo – Viewed backward from the second hill, this photo looks at the downward slope of the first hill into a ravine. The tail assembly is at the extreme upper left corner, beneath the two trees. The skin of the right aft fuselage and top of fuselage is the white material at the right edge of the photo, above the green vegetation. The upper edge of the first ravine is visible along the bottom of the photo, which then drops out of sight.**

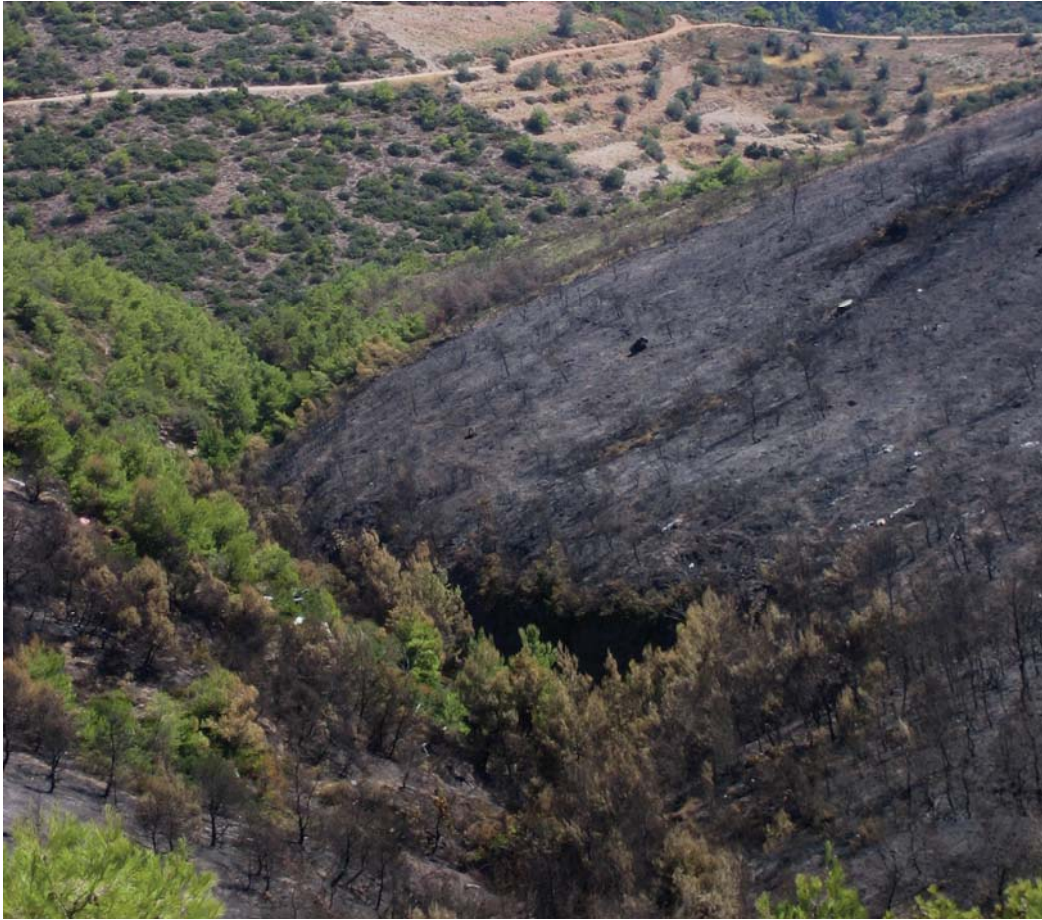
**Photo – The downhill slope from the first peak is to the left and the upward slope to the peak of the second hill is to the right. The dark debris in the center of the upward slope to the right is half of the left engine.**

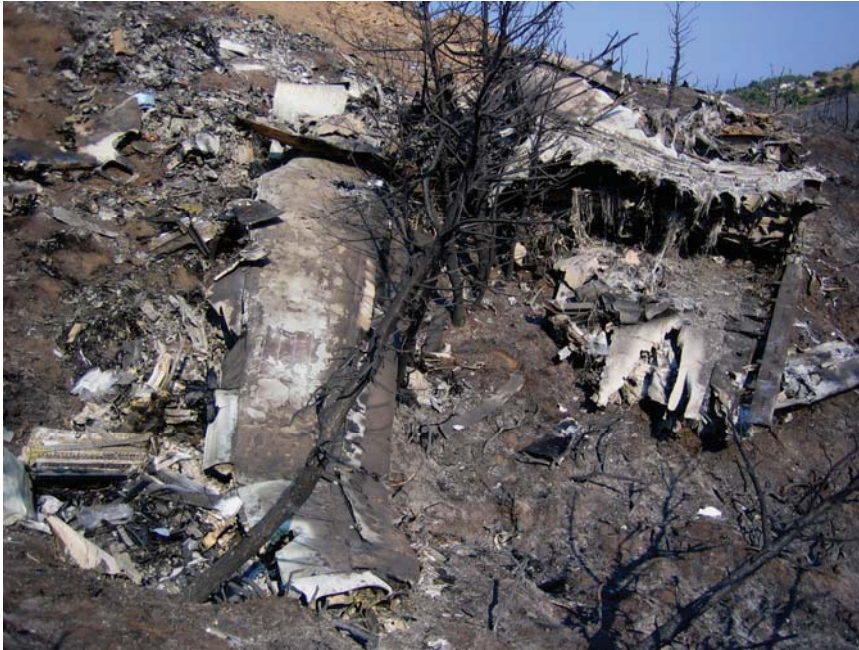
The nearly complete wings assembly was found about halfway down the second slope. The main landing gear well was burned out and was found about 12 m uphill from the wings. The wings were found folded so that the tips were downhill (See photo below).

**Photo – The right wing tip is at the lower left and the left wing is at the right edge of the photo. The center section and main gear well is at top right.**

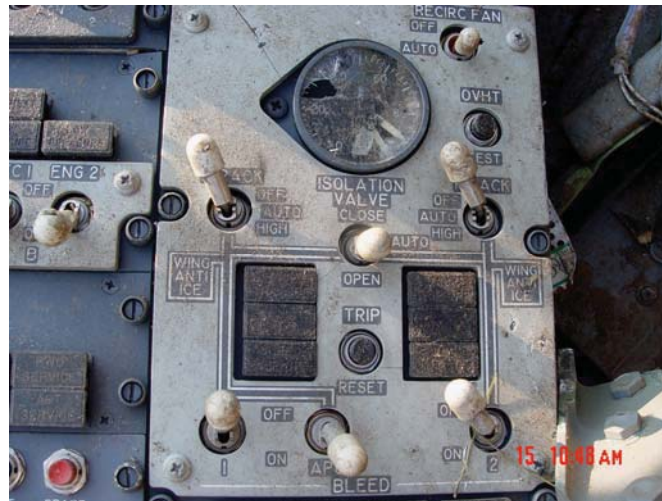
**Photo – Air Conditioning Panel**

The P5-10 air conditioning panel remained in the P5 overhead panel (See photo below). The panel was photographed and the positions of each toggle switch and the duct pressure indicator were documented.

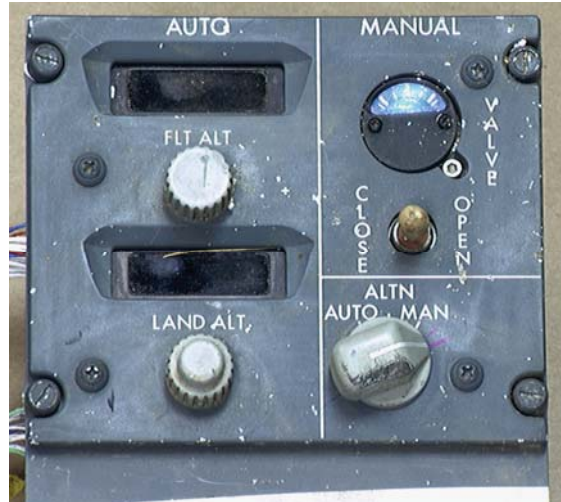
**Photo – Pressurization Panel**

The P5-5 cabin pressurization panel was found intact and remained in the P-5 overhead panel. The position indicator of the cabin pressure mode selector was found rotated past the MAN (manual) position (on the faceplate) by approximately 7.0 mm. It was later determined by the Boeing EQA that the damage was consistent with physical impact. The selector had an abrasion, in line with the selector line, on its right side at the lower corner. The panel face plate in the vicinity of the AUTO nomenclature had a 180 degree circular impression of the selector base. The center mark on the selector was about 10 degrees from the start of the circular impression (See photo below).

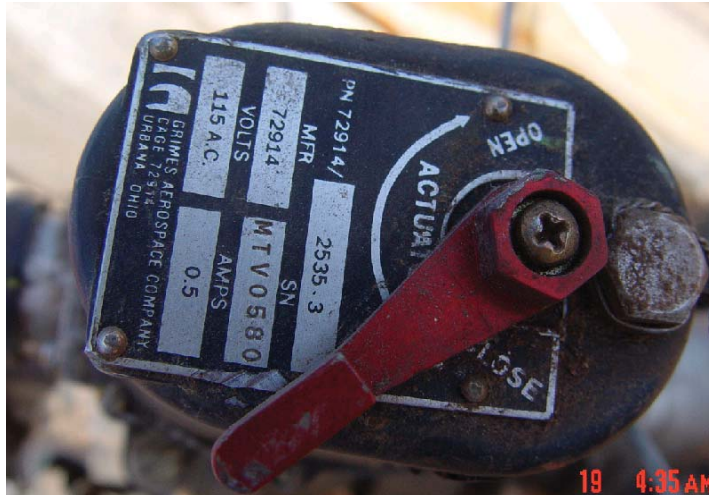
**Photo - Forward Outflow Valve**

The Forward Outflow Valve (photo below), manufactured by Grimes Aerospace Co., was found intact and connected to its ducting. The manufacturer Commercial and Government Entity (CAGE) code number on the actuator was 72914, which indicated that the actuator was made by Honeywell (the parent company of Grimes Aerospace Co.). The part number and serial number of the actuator were 2535-3 and MTV0580, respectively. The actuator was a subassembly of the Forward Outflow Valve, P/N 32-2684-007. The valve position indicator lever remained in the closed position, and an electrical connector remained connected to the valve assembly. A tag on the valve stated *“installation eligibility Boeing 747-200, 747-300, 747-400.”* According to Boeing, this valve is the *“approved 737 forward outflow valve as verified by part number 32-2684-007 ... the part is also approved for use on the 747.”* The butterfly valve contained within the assembly was in the closed position.

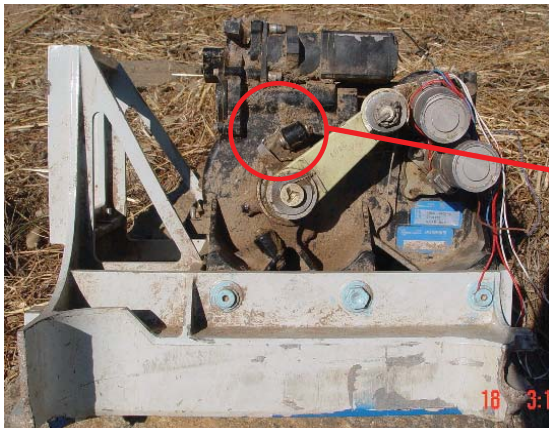
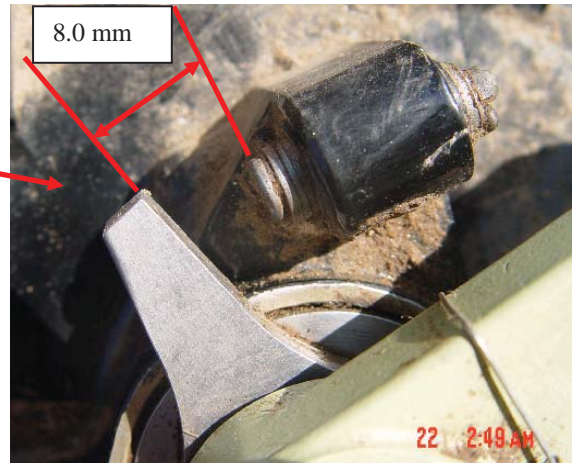
**Photo - Aft Outflow Valve at accident site**

The actuator/motor assembly and both the forward and aft door gates of the aft outflow valve (AOV) were found at the accident site (see diagram and photos below and next page). The actuator/motor assembly was separated from each of the door gates. The condition of the actuator/motor assembly was documented and photographed at the accident site. The control arm and position indicator remained attached to the motor assembly. Using hand pressure, a small force was applied to the control arm; it was physically locked in place and not able to rotate freely. At the storage facility, a measurement was taken between the closed position stop and the control arm position lever; the distance between the two was 8.0 mm (see photo in the next page).

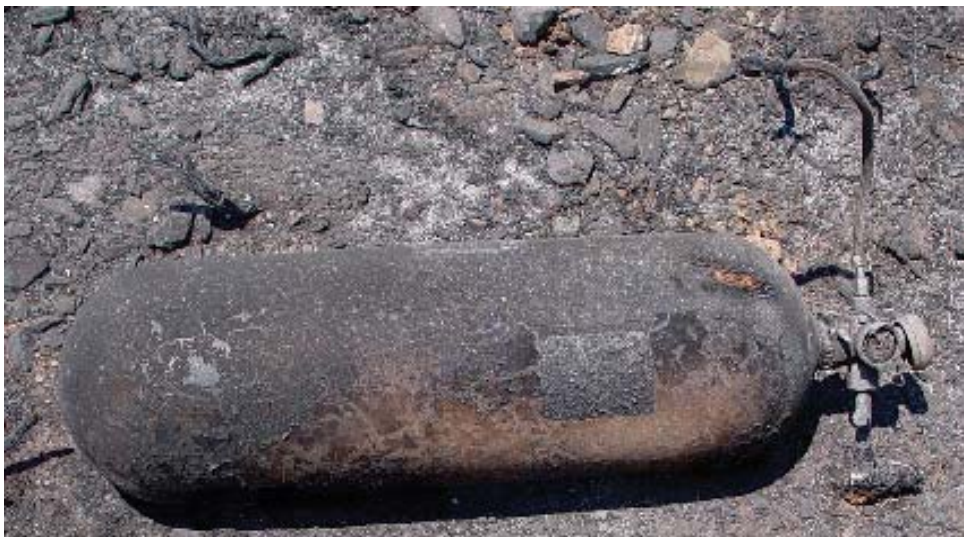
**Photo - Flight deck oxygen cylinder**

The flight deck oxygen cylinder was found heat damaged and the regulator was missing. (See photo - Flight deck oxygen cylinder). The shutoff valve assembly was observed to be loose on the cylinder and it could easily be rotated in the clockwise and counter-clockwise direction. At the storage facility, the cylinder was visually examined and the regulator valve was physically rotated. Using hand pressure, a force was applied to the regulator valve in the counter-clockwise (valve open) direction; the valve did not rotate. Using hand pressure, a force was applied to the regulator valve in the clockwise (valve closed) direction; the valve rotated six revolutions. The cylinder was empty. The last hydrostatic check had been carried out in September 2003 (09/03 dye stamp on cylinder neck).

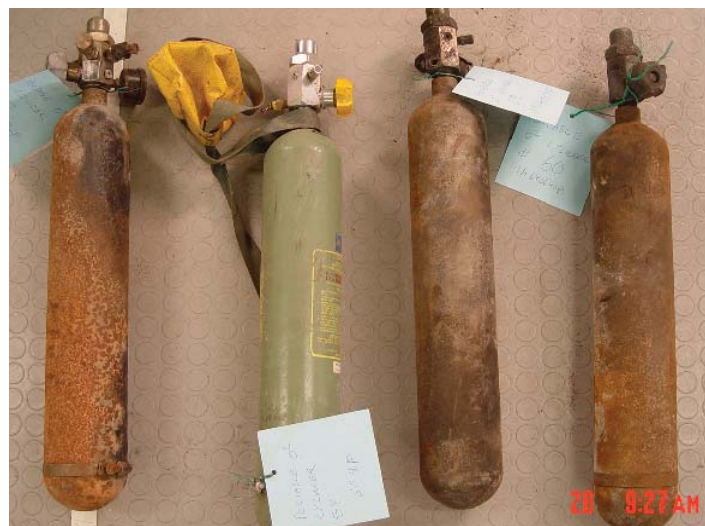
**Photo – Portable Oxygen Bottles**

- Bottle number 4: The bottle had been exposed to heat. The paint was missing and the exterior of the bottle appeared to be slightly rusted. The shut-off valve was rotated 1 ½ revolutions clockwise to the fully closed position.

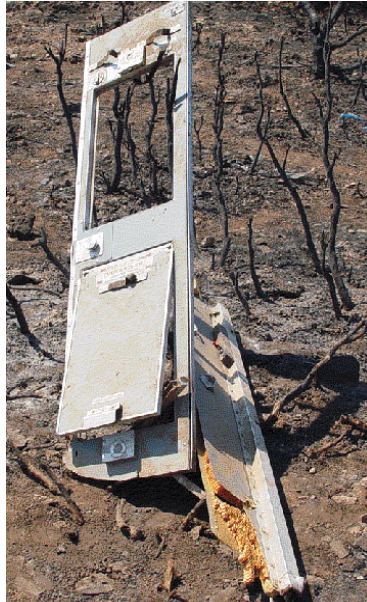
**Photo – Flight deck door**

on either side of flight deck door faces or lower blow out panel. The door upper blow-out panel was missing. The flight deck access system guarded switch on the door side post fragment was observed to be positioned to “NORM”. The flight deck door deadbolt was found in the “UNLOCKED” position (vertical).

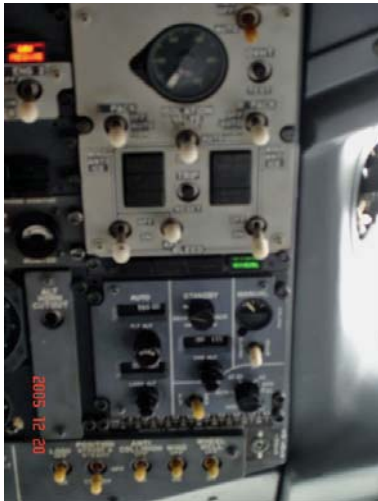
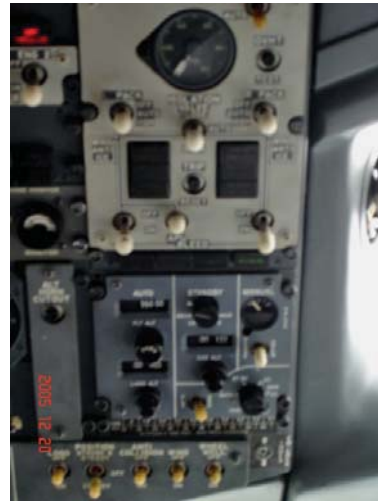
on DIM and looking up to the overhead panel from the First Officer's seat, the green annunciation MANUAL was not particularly obvious.
